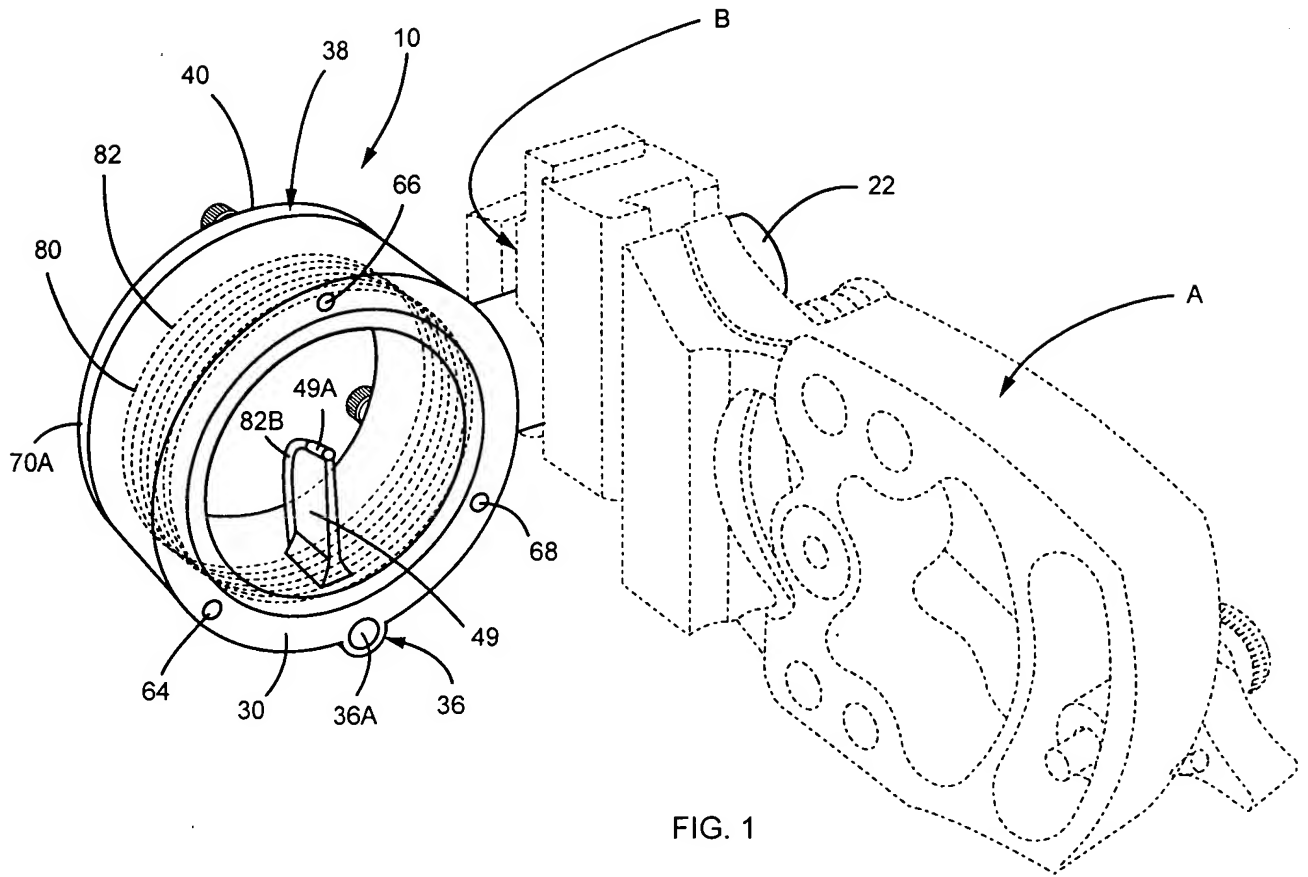
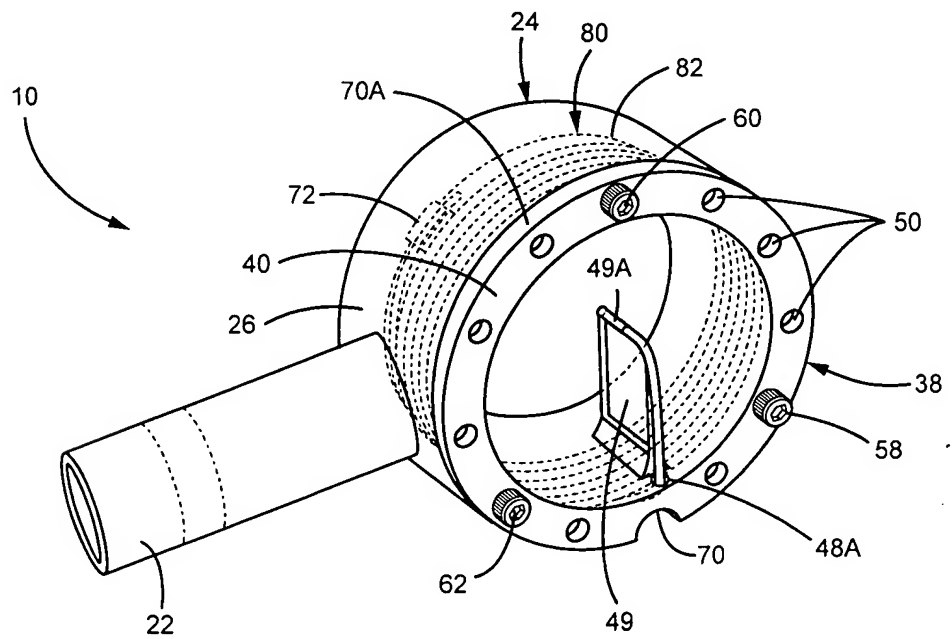
FIG. 3

This exploded perspective view shows the assembly 10 in a disassembled state. It includes a cylindrical component 22, a flange-like component 20 with a central opening 24 and a flange 26, and a main body component 30. The main body 30 has a threaded section 32 and a flange 34. A cylindrical component 42 is shown with a threaded section 44 and a flange 46. A cylindrical component 48 is shown with a threaded section 49 and a flange 50. A cylindrical component 52 is shown with a threaded section 54 and a flange 56. A cylindrical component 58 is shown with a threaded section 60 and a flange 62. The assembly 10 is shown in a disassembled state, with the components 22, 20, 30, 42, 48, 52, and 58 arranged around the main body 30.
